The Benefits of Using Recycled Crushed Aggregates in Infrastructure Projects Study Report

Study Report

BRM-22019043-B0

Toronto and Area Road Builders Association (TARBA)
5045 Orbitor Drive, Unit 12, Suite 300
Mississauga, ON L4W 4Y4

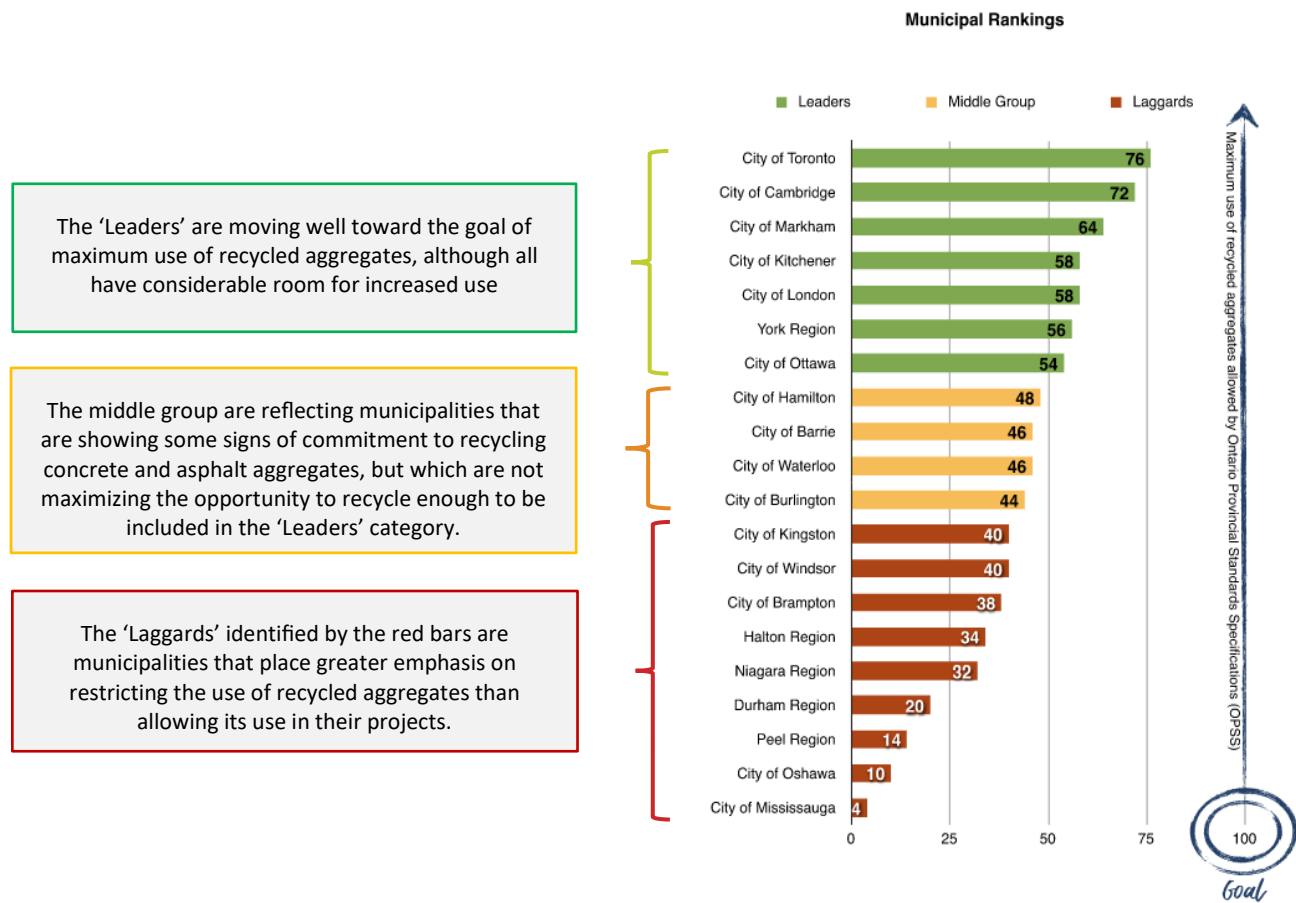
Figure 2. TARBA Leaders and Laggards, Results from April 2018 Independent Study [1]

The study ranked the “leaders” and “laggards” and outlined the maximum use of recycled aggregates allowed by Ontario Provincial Standards Specifications (OPSS) [1]. **Figure 2** is the graphic from the final report. Leaders include the Cities of Toronto and Markham, where practices align with Climate Action Goals from reducing the carbon footprint across the cities’ buildings, sites, fleet vehicles and infrastructure. To that point, best practices and standards from these leaders can be used to challenge the Middle Group and Laggards to follow suit and increase the use of RCA within their municipalities.

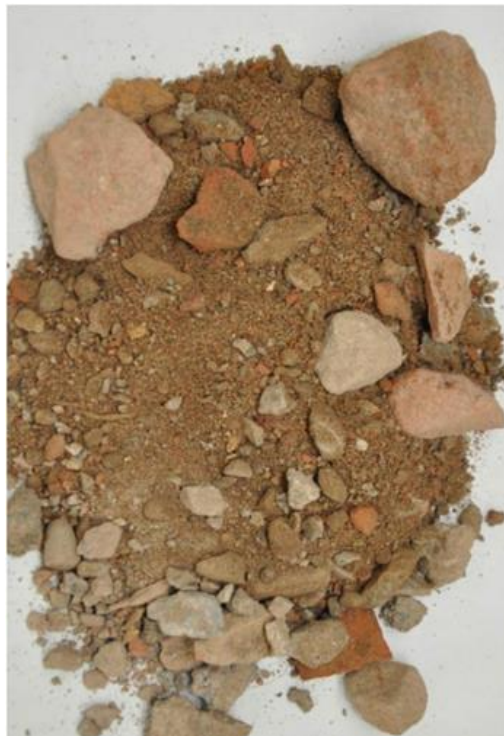
Figure 12. Photo of Building Derived Concrete (BDC) [12]

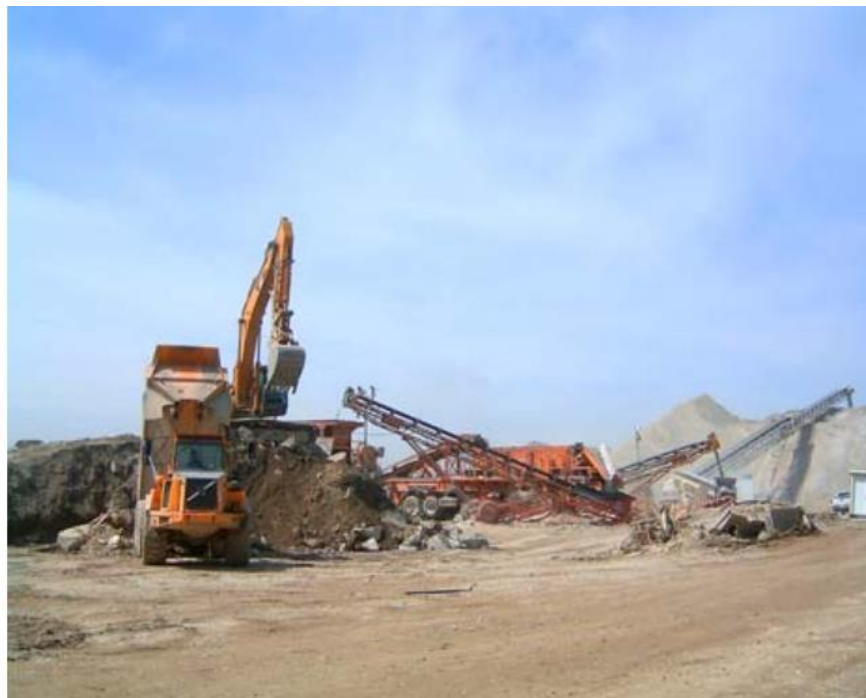
Figure 14. Pearson International Airport – One Site Concrete Crushing Plant and Processed Concrete Backfill (2004)

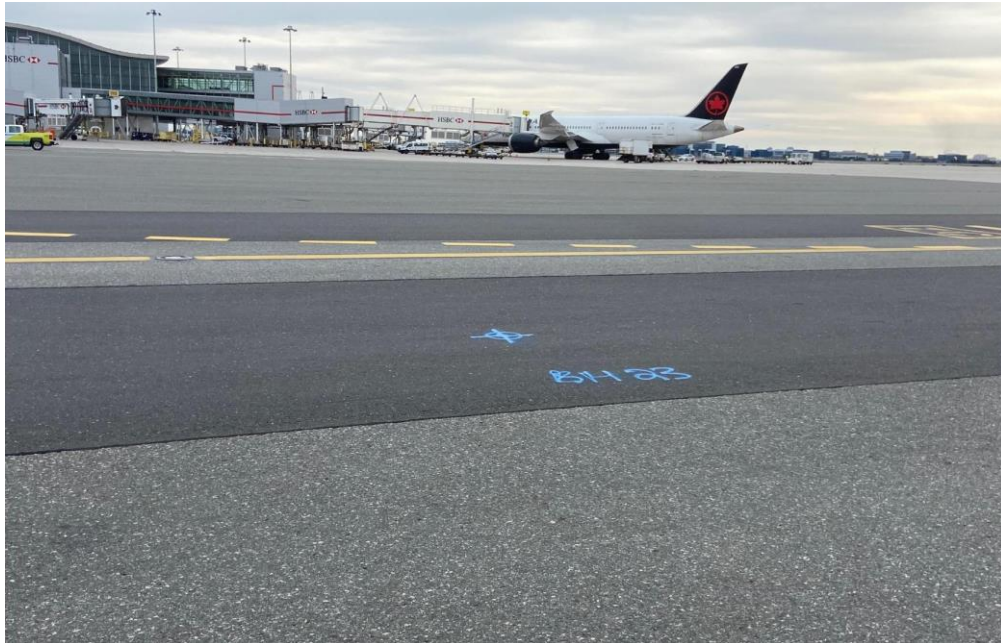
**Figure 15. Pearson International Airport – T1 Apron Asphalt
Observed Patches in Fair Condition (EXP - November 2021)**

- **Age of Existing Pavement:** The age of the existing flexible pavement is about 16 years, considering that original construction was between 2004 and 2006. A few localized resurfacing activities were carried out in 2016 and 2019 for not tracked areas. No rehabilitation works were carried out since original construction of the T1 Apron.
- **Pavement Condition and Observed Defects at T1 Apron:**
 The existing flexible pavement is in fair condition (including previous localized patches) with occasional construction joint cracking ~~is~~ being of slight to moderate severity and slight asphalt raveling, as shown in **Figure 15** and **Figure 16** for 2021 site photographs.

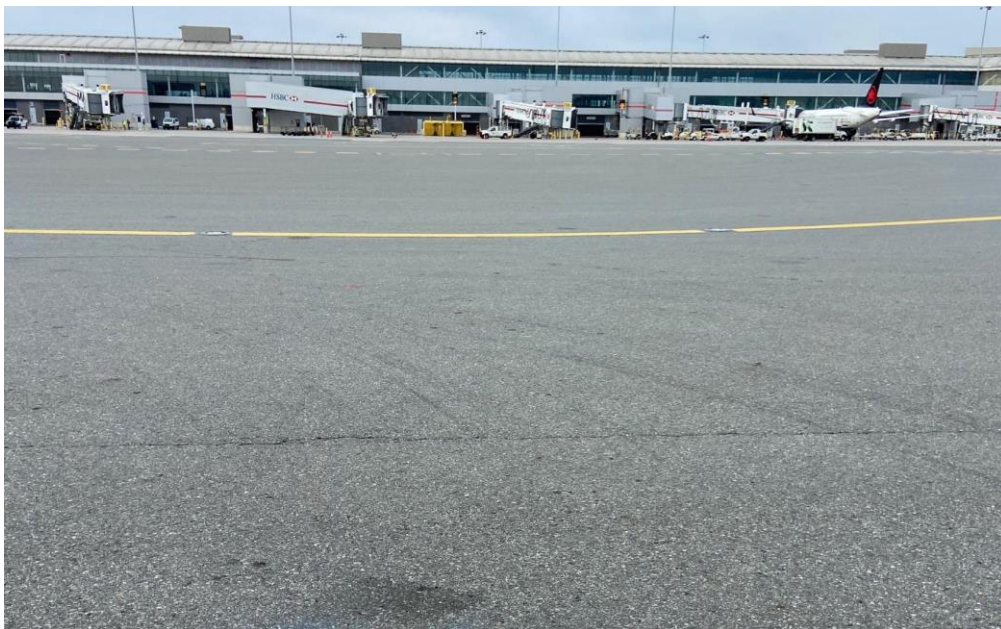
**Figure 16. Pearson International Airport – T1 Apron Asphalt, Occasional
Construction Joint Cracking in Slight to Moderate Severity.
Occasional Asphalt Raveling in Slight Severity (EXP - November 2021)**

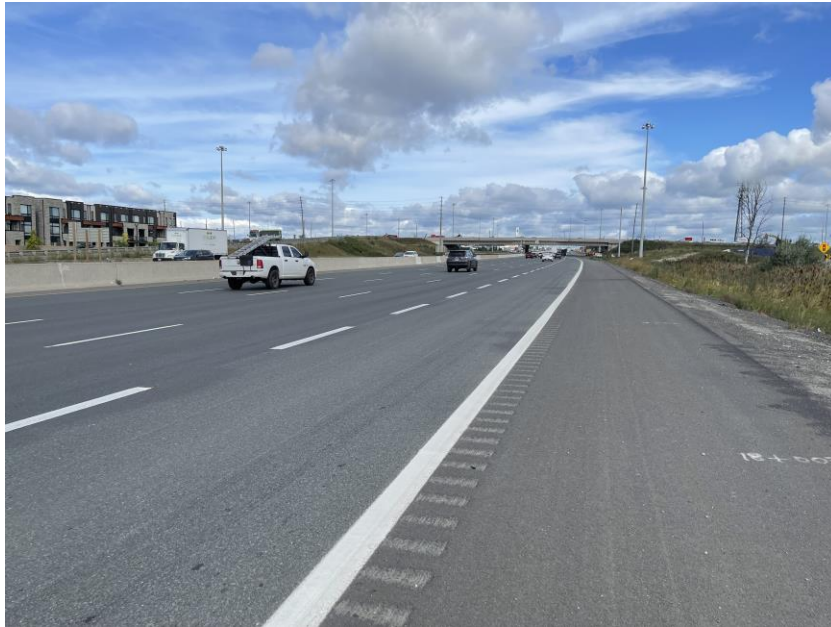
Figure 18. Highway 400- NB – Before Teston Road Bridge- No Distresses (September 2022)

Current Pavement Condition: Based on EXP’s site visit on September 20th, 2022, the pavement condition is excellent with no distresses as shown in the following **Figures 18, 19, 20, and 21.**

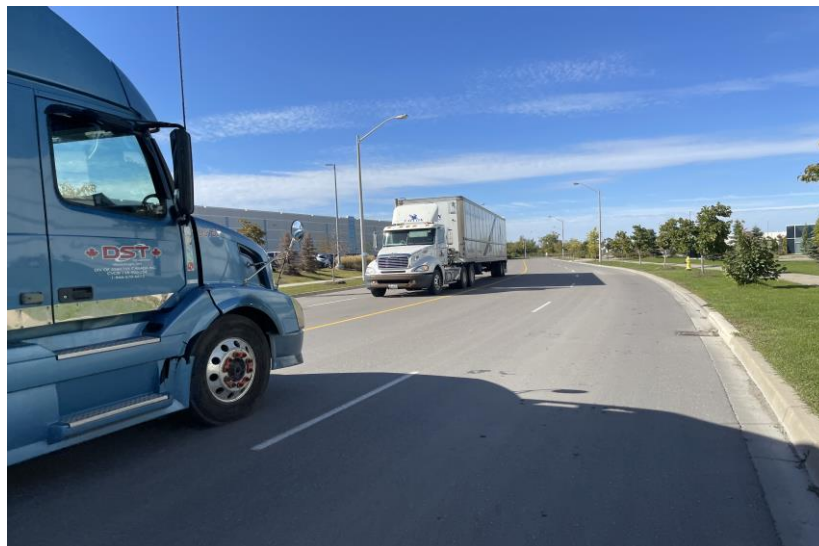
Figure 29. Huntington Glen – Hunter’s Valley Road (October 2022)

- The pavement of all streets within Huntington Glen Development in City of Vaughan are in good condition, without any structural failures. Refer to **Figure 29** through **Figure 32** for site photographs.

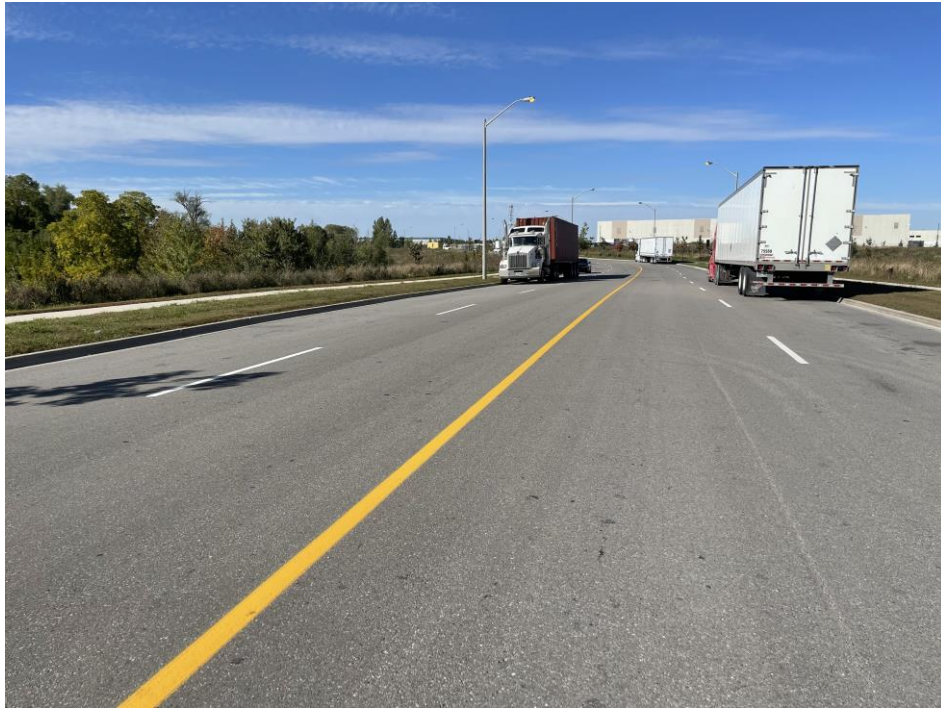
Figure 30. Huntington Glen – Hunter’s Valley Road (October 2022)

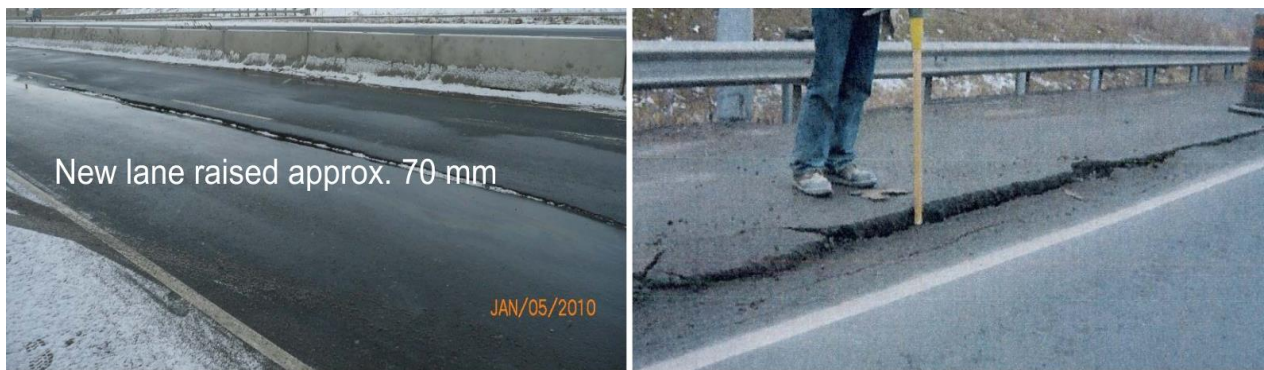
- 1) The new lane as part of pavement widening was raised/heaved approx. 70 mm, as shown in site photographs in the following **Figure 34**.

Figure 34. Highway 427 – Pavement Heaving in 2010

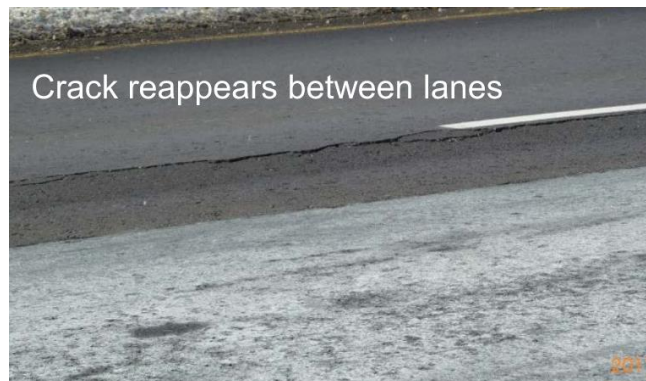
- 2) Crack reappears between lanes, as shown in site photographs dated 2011 in the following **Figure 35**.

Figure 35. Highway 427 – Reappearance of Cracks Between Lanes in 2011

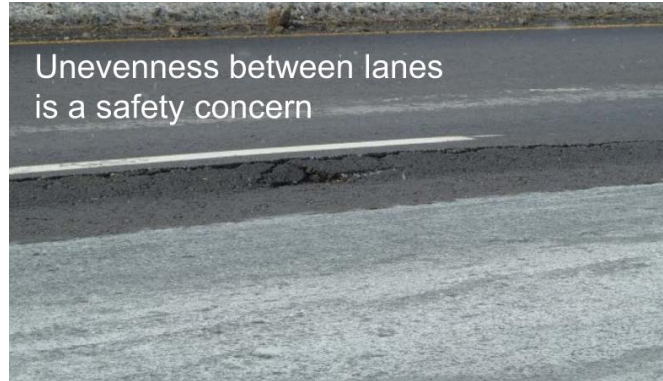
- 3) Unevenness between lanes (Safety Concerns) as shown in site photographs in the following **Figure 36**.

Figure 36. Highway 427 – Pavement Distresses Between Lanes in 2010 - 2011

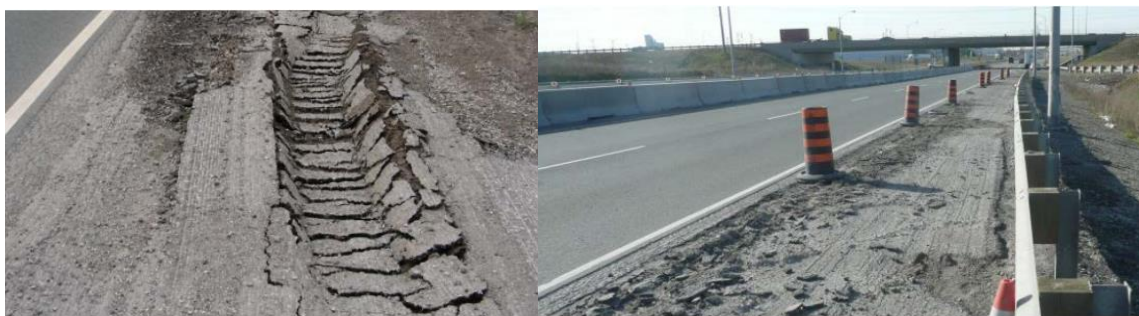
- 5) Other Problems, as shown in site photographs in the following Figure 38.

Figure 38. Highway 427 – Different Pavement Distresses (2010 -2011)

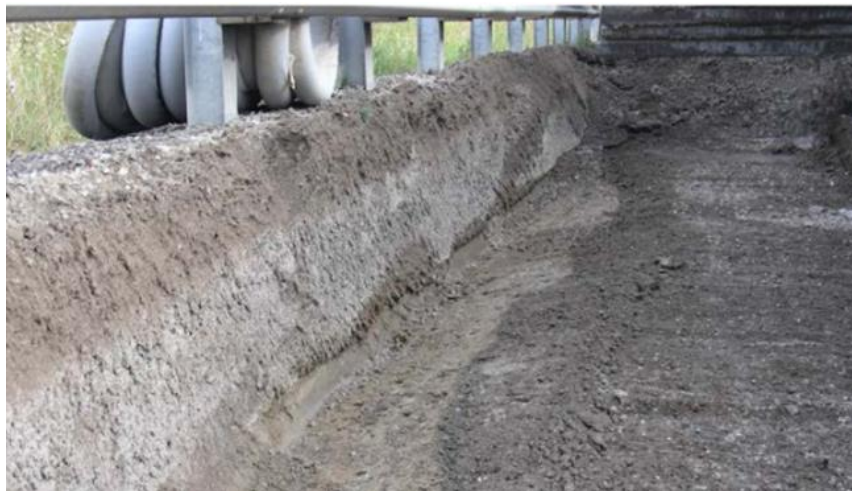
- ✓ New highway constructed adjacent to existing highway that has been in operation for approximately 20 years, as shown in **Figure 39** for site photograph.

Figure 39. Highway 427 – New Highway Constructed Adjacent to Existing Highway

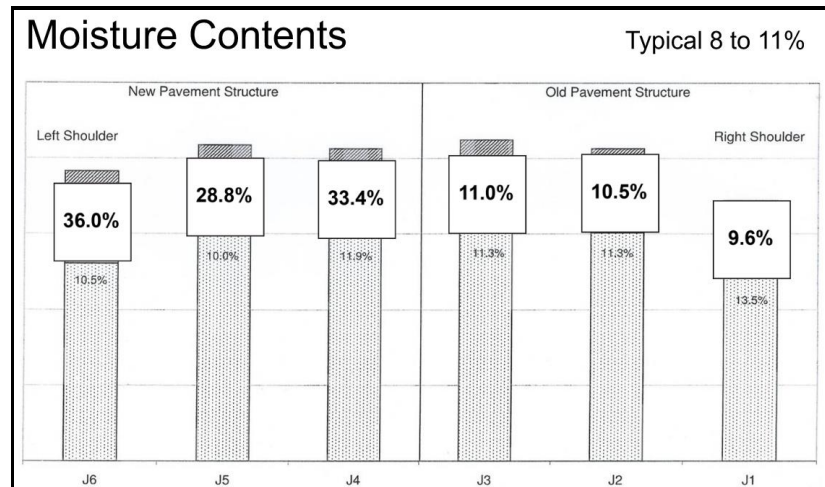
- ✓ Expect similar moisture contents between the old and new pavement structure as shown in the following **Figure 40**.

Figure 40. Highway 427 – Moisture Contents for Old and New Pavement Structures

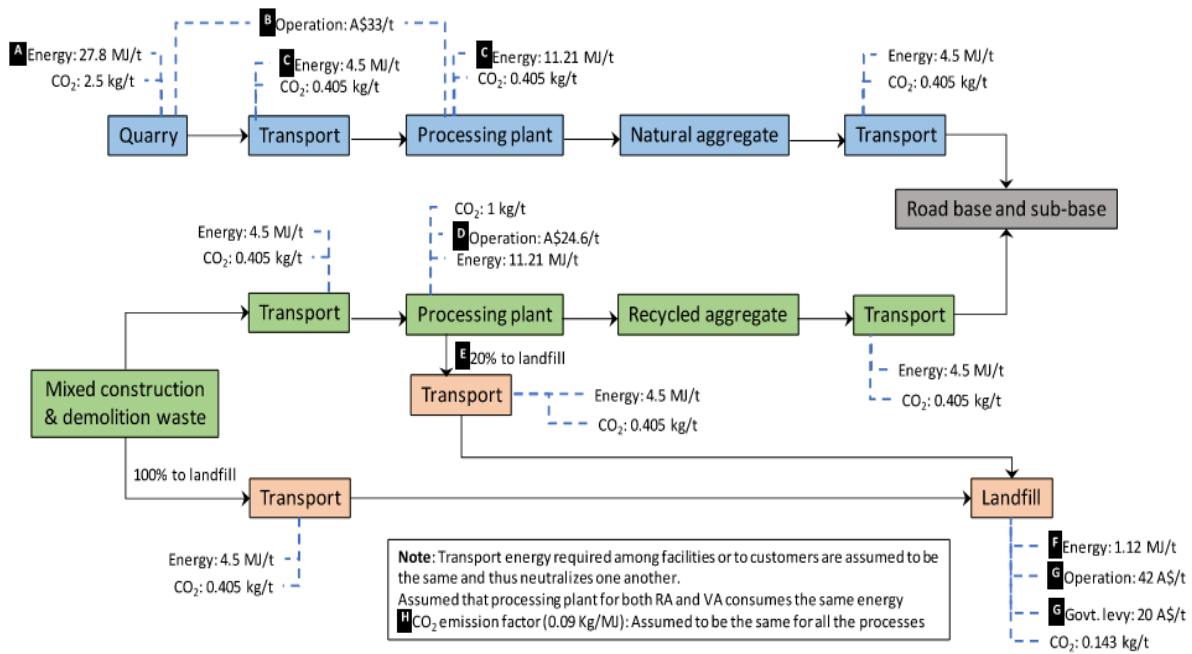
Figure 42. Life Cycles of virgin and recycled aggregates and associated costs in different phases [22]

Figure 42 depicts the lifecycle described in the foregoing paragraph. Though included in the figure, energy, cost and GHG emission impacts from the additional process for the diversion of the non-usable CDW to the landfill is excluded from our analysis [22].

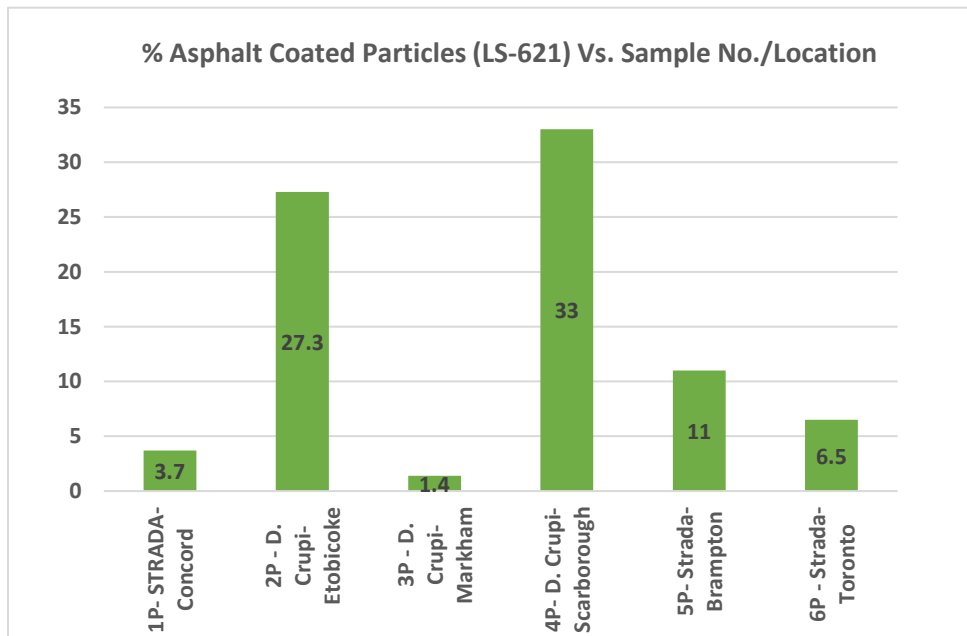
- The average percentage of *Asphalt Coated Particles* is 13.8 % (ranged from 1.4 % to 33 %). Noted that 84 % of the tested samples (5 out of 6 sample) are acceptable (below maximum allowable limit of 30 % according to OPSS1010). The percentage in one sample (sample # 4P) is 33 % (marginally above the acceptable limit). **Figure 47** summarizes the related test results of the Asphalt Coated Particles for the tested samples.

Figure 47: Histogram for % Asphalt Coated Particles of Tested Samples

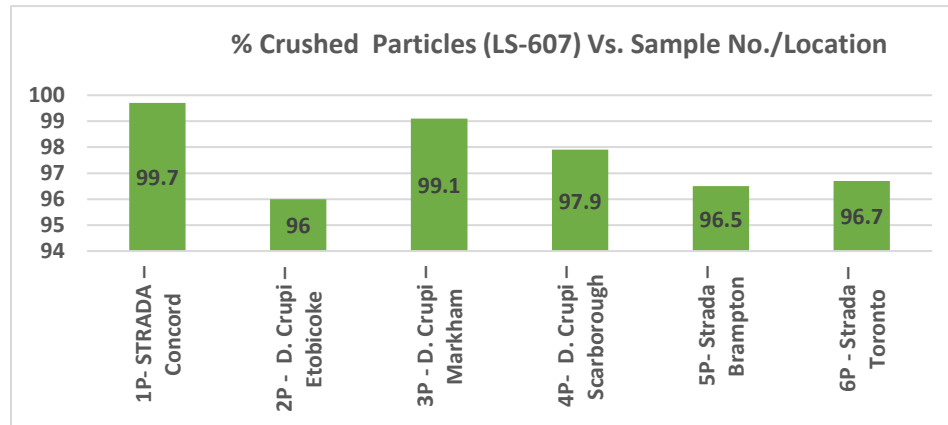
- The average percentage of *Crushed Particles* is 98 % (ranged from 96 % to 99.7 %). Noted that 100 % of the tested samples are acceptable (above the minimum acceptable limit of 60 % according to OPSS1010). **Figure 48** summarizes the related test results of % Crushed Particles for the tested samples.

Figure 48: Histogram for % Crushed Particles of Tested Samples

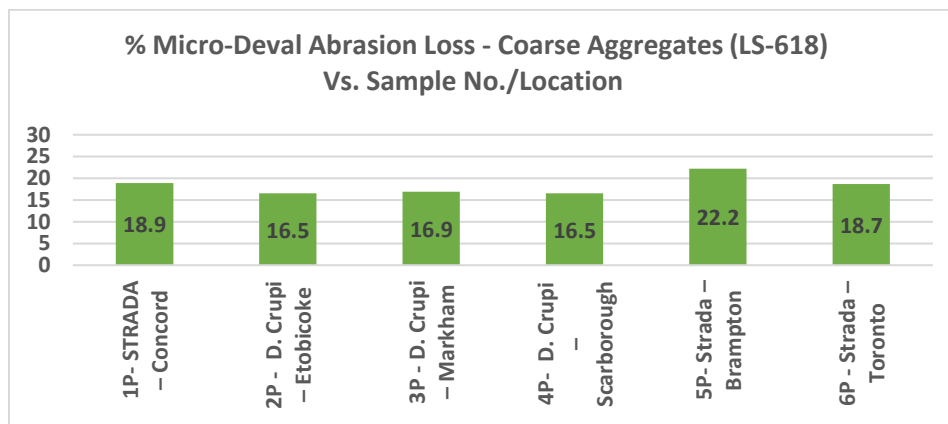
- The average percentage of *Micro-Deval Abrasion Loss (for coarse aggregate)* is 18.2 % (ranged from 16.5 % to 22.2 %). Noted that 100 % of the tested samples are acceptable (below the maximum acceptable limit of 25 % according to both OPSS1010 and TS1010). **Figure 49** summarizes the related test results of % Micro-Deval Abrasion Loss (for coarse aggregate) for the tested samples.

Figure 49: Histogram for % Micro-Deval Abrasion Loss (for coarse aggregate) of Tested Samples

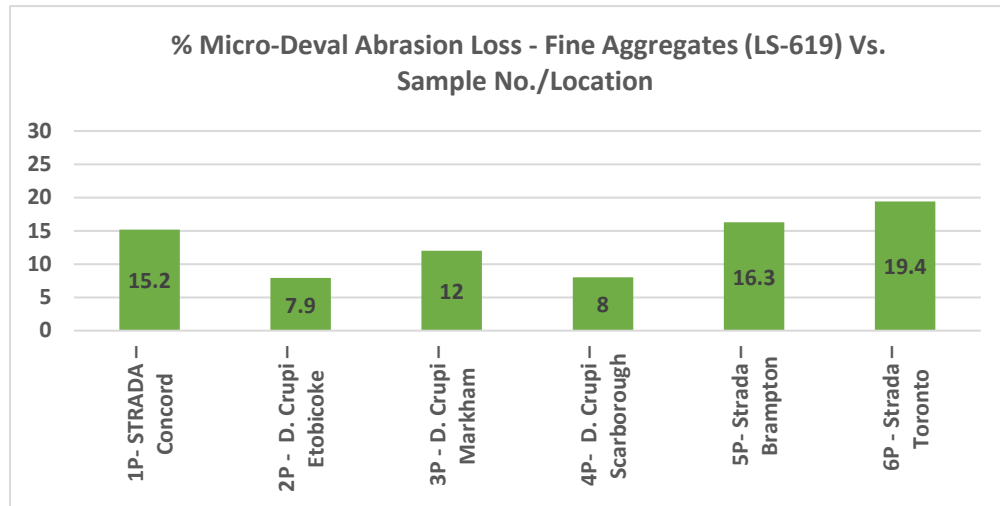
- The average percentage of *Micro-Deval Abrasion Loss (for fine aggregate)* is 13.1 % (ranged from 7.9 % to 19.4 %). Noted that 100 % of the tested samples are acceptable (below the maximum acceptable limit of 30 % according to OPSS1010). **Figure 450** summarizes the related test results of % Micro-Deval Abrasion Loss (for coarse aggregate) for the tested samples.

Figure 50: Histogram for % Micro-Deval Abrasion Loss (for fine aggregate) of Tested Samples

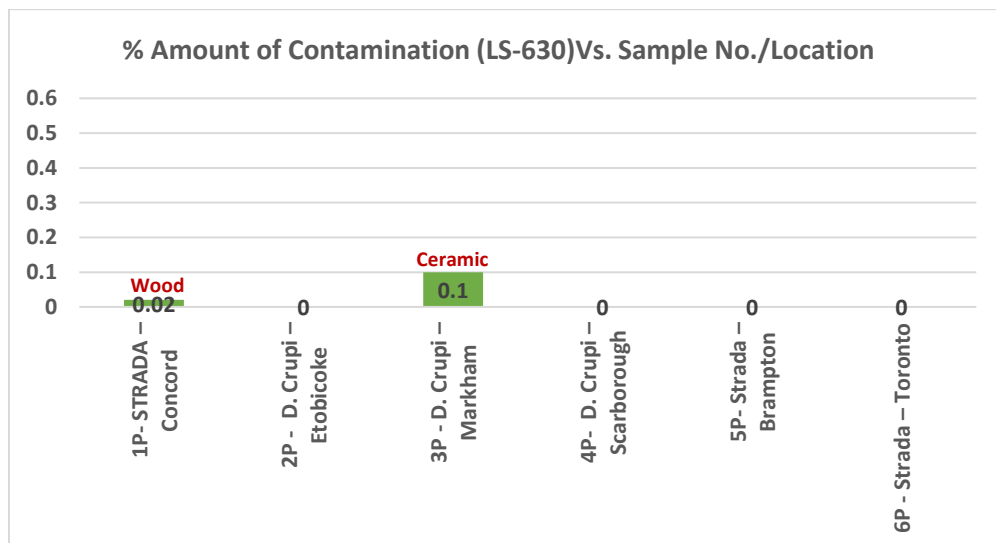
Figure 51 shows the related test results of the percentage of Amount of Contamination for the tested samples of coarse aggregate of Gran A (RCA1010).

Figure 51: Histogram for % Amount of Contamination (for Coarse Aggregate -LS630) of Tested Samples

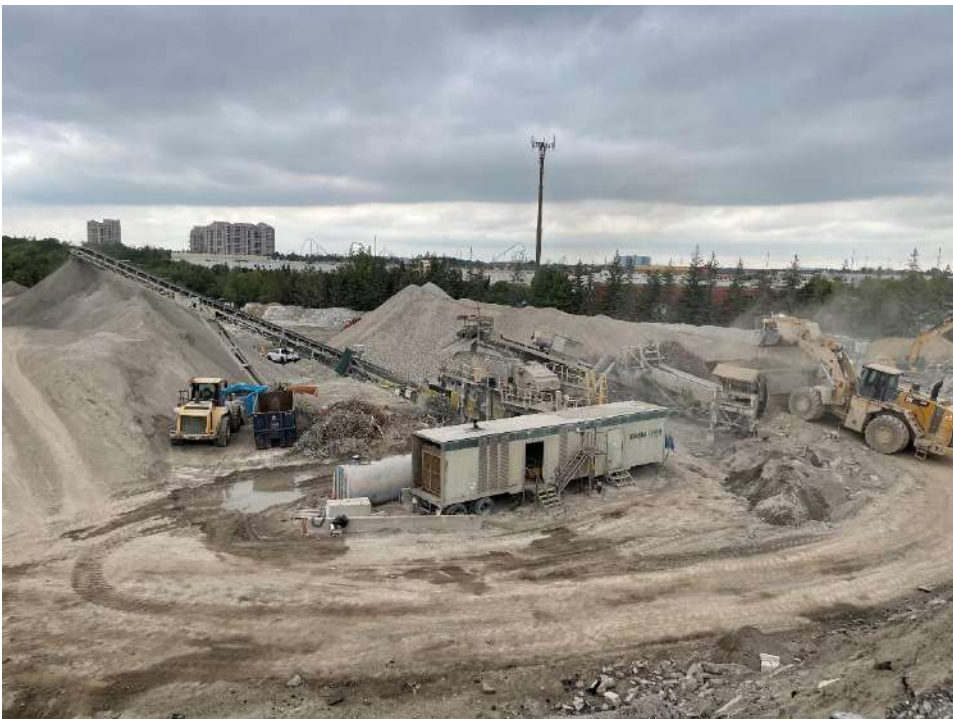
Photo (4): Strada Crusher at 1667 Creditstone Rd, Concord, ON – Producing RCA

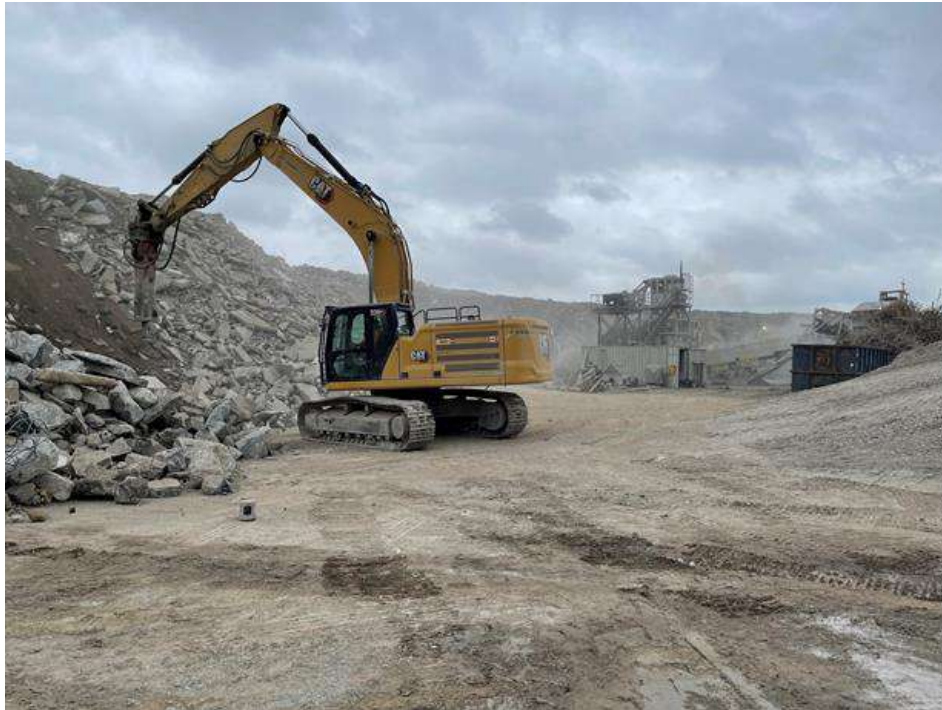
Photo (5): Strada Crusher at 1667 Creditstone Rd, Concord, ON – Breaking Big Pieces

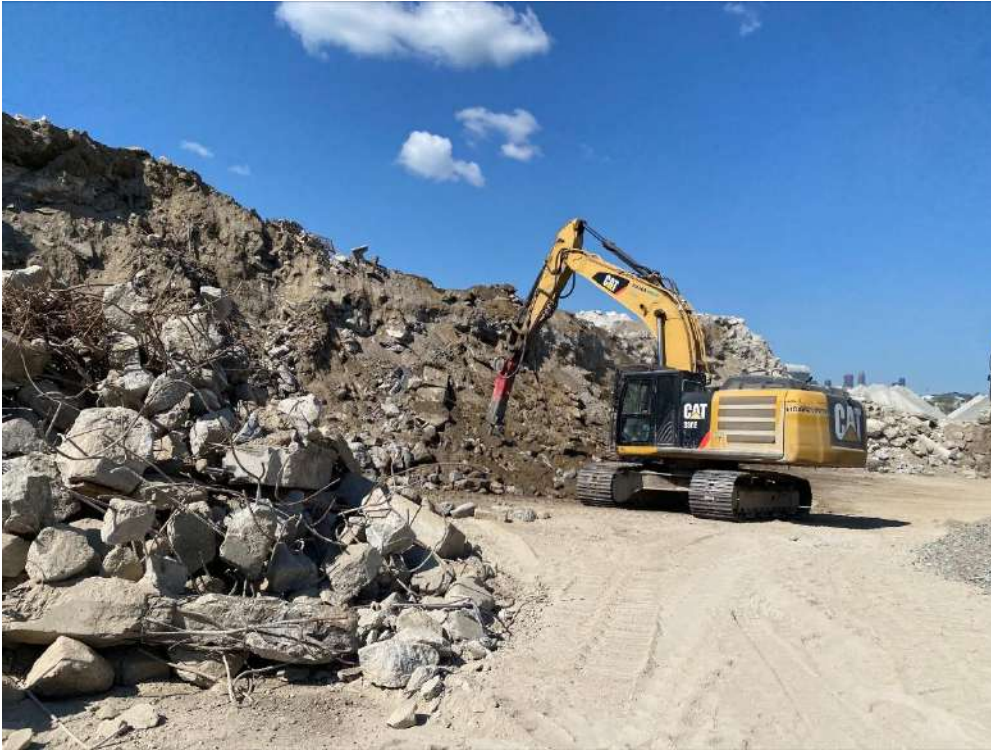
**Photo (31): Strada Aggregate Crusher: 10 Leslie St, Toronto, ON
Breaking Big Pieces of Concrete Prior Crushing**
